**Flood Control Project Maintenance
Levee Inspections**

Fall 2016 Levee Maintenance Deficiency Summary Report

Sutter Maintenance Yard East-West Interceptor

Levee Inspection Report By Mile - Fall 2016

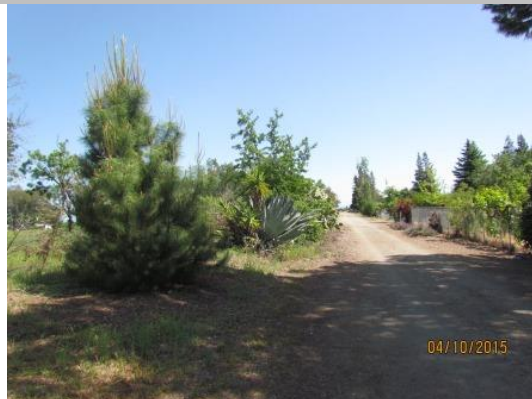
Photo 2 of 2 : FA_2016_ST0020_213_2_20160823_00002.jpg

LM Start	0.23	Rating **	M	Issue No.	2 (cont)	
LM End	0.25	Issue Type +	En	Location *	CR	
Category	Earthen Levee			GPS Latitude/Longitude		
				Start		End
Item	Vegetation			39.171418 °		39.171408 °
				-121.755963 °		-121.755578 °
DWR ID	DWR_NA0020_01_s_2012_2					
Comment Code						
V6 : Landscaping						
Inspector Comment						
Remove the cactus and pine trees from the waterside berm.

Another view of the cactus and pine trees along the waterside berm.

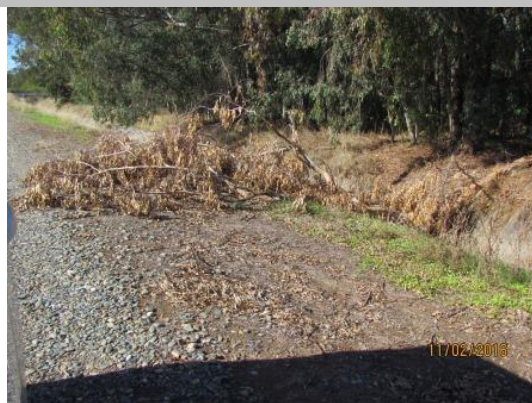
Photo 1 of 1 : FA_2016_ST0020_213_14_20161107_00018.jpg

LM Start	0.43	Rating **	M	Issue No.	14
LM End	0.43	Issue Type +	Ma	Location *	WS
Category	Earthen Levee			GPS Latitude/Longitude	
				Start	End
Item	Encroachments			39.171422 °	39.171422 °
				-121.751978 °	-121.751978 °
DWR ID	DWR_ST0020_01_f_2016_14				
Comment Code					
TR : Tree or limb					
Inspector Comment					
Remove the tree limb from the waterside.

View of a fallen limb.

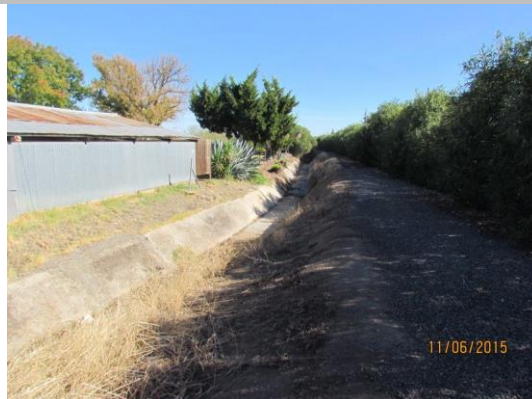
Photo 1 of 2 : FA_2016_ST0020_213_4_20160823_00005.jpg

LM Start	0.62	Rating **	U	Issue No.	4
LM End	0.65	Issue Type +	Ma	Location *	WS
Category	Earthen Levee			GPS Latitude/Longitude	
				Start	End
Item	Erosion / Bank Caving			39.171292 °	39.171232 °
				-121.748868 °	-121.748175 °
DWR ID	DWR_NA0020_01_s_2012_4				
Comment Code					
E2 : Schedule repair of erosion site prior to the next inspection.					
Inspector Comment					
Repair the erosion along the concrete ditch.

View the erosion along the concrete ditch.

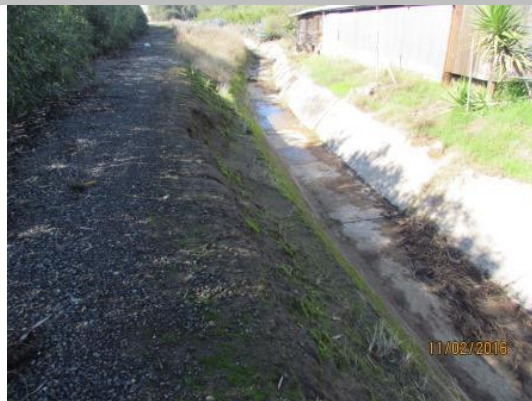
Photo 2 of 2 : FA_2016_ST0020_213_4_20161107_00020.jpg

Another view the erosion along the concrete ditch.

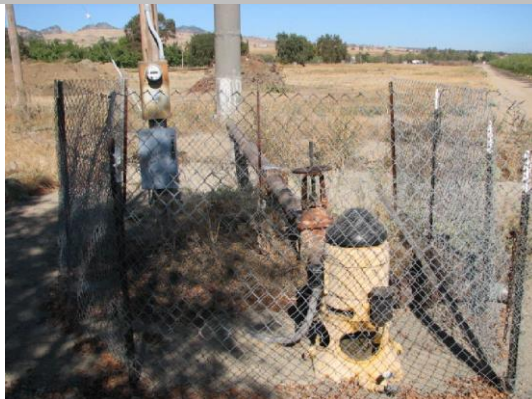
Photo 1 of 2 : UCIP_FA_2016_50325_11344.jpg

FS_ID:50325
DS_ID:19417
EP_NO: N/A
Repair Type: Non-Urgent
Crossing Status: Found
UCIP Comments: 4/19/2016 Meter has been removed from the power box and the power lines have been disconnected from the pole and pump. Appears this crossing may have been abandoned.5/12/2015 Crossing appears in good condition. No noticeable issues to report.11/17/2014 Same as last inspection.5/12/2014 Same as last inspection.11/4/2013 Same as last inspection.5/15/2013 Same as last inspection.
FIELD_STRUCT_DESC: 12-inch steel irrigation pipe crosses over canal above crown elevation. Chain link enclosure on the landside (LS) with pump, power line, and shutoff valve. 24-inch concrete standpipe on unprotected side of canal. [Additional Reference(s): DWR Levee Log, Revised 1990]
FS Date: 10/12/2016 7:47:42 AM

Pump, meter, power pole, slide gate, and chainlink fence on LS with 24-inch concrete standpipe on unprotected side of canal.

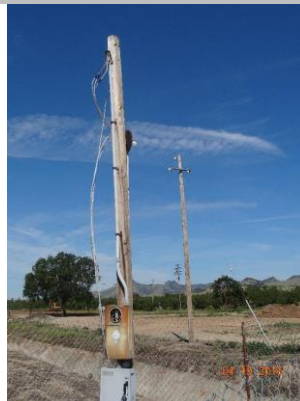
Photo 2 of 2 : UCIP_FA_2016_50325_74963.jpg

Meter removed from box and disconnected power lines

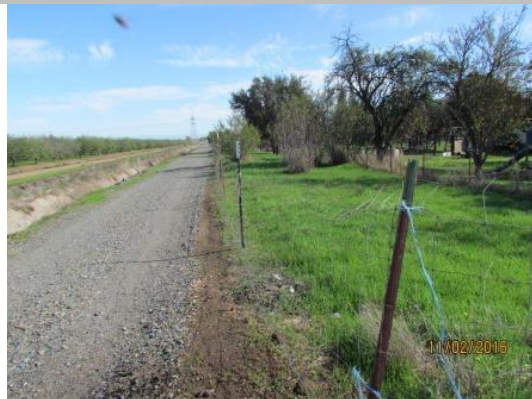
Photo 1 of 1 : FA_2016_ST0020_213_16_20161107_00021.jpg

View of an unauthorized fence by a landowner.

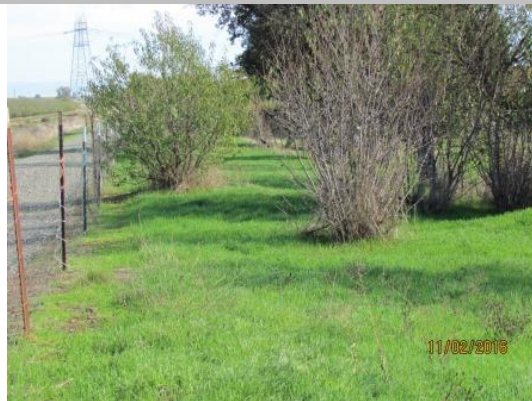
Photo 1 of 1 : FA_2016_ST0020_213_17_20161107_00022.jpg

LM Start	0.94	Rating **	M	Issue No.	17
LM End	0.98	Issue Type +	En	Location *	LS
Category	Earthen Levee			GPS Latitude/Longitude	
				Start	End
Item	Encroachments			39.171333 °	39.171333 °
				-121.742577 °	-121.741827 °
DWR ID	DWR_ST0020_01_f_2016_17				
Comment Code					
CR : Crops					
Inspector Comment					
Ask the landowner to remove the nut trees.

View of the nut trees planted by a landowner.

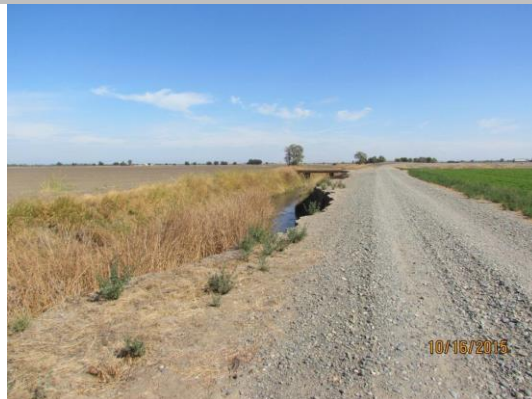
Photo 2 of 2 : FA_2016_ST0020_213_6_20160823_00008.jpg

LM Start	1.65	Rating **	U	Issue No.	6 (cont)	
LM End	1.65	Issue Type +	Ma	Location *	WS	
Category	Rivers, Channels & Designated Floodways			GPS Latitude/Longitude		
				Start		End
Item	Erosion / Bank Caving			39.171132 °	39.171132 °	
				-121.729312 °	-121.729312 °	
DWR ID	DWR_NA0020_01_s_2012_6					
Comment Code						
Inspector Comment						
Sutter Yard needs to repair the erosion before winter.

Repair the erosion along the waterside slope.

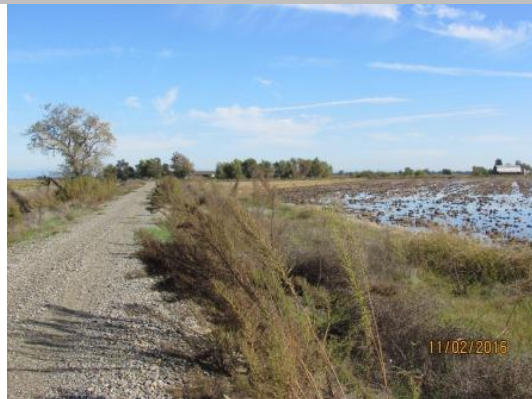
Photo 1 of 1 : FA_2016_ST0020_214_11_20161107_00045.jpg

View of the annual grass along the landside slope.

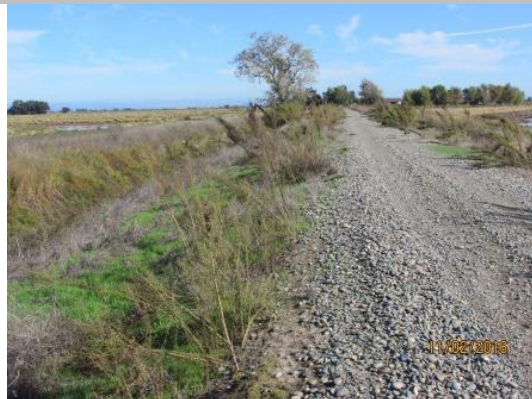
Photo 1 of 1 : FA_2016_ST0020_214_24_20161107_00046.jpg

LM Start	0.03	Rating **	M	Issue No.	24
LM End	0.25	Issue Type +	Ma	Location *	WS
Category	Earthen Levee			GPS Latitude/Longitude	
				Start	End
Item	Vegetation			39.171152 °	39.171160 °
				-121.725937 °	-121.721673 °
DWR ID	DWR_ST0020_02_f_2016_24				
Comment Code					
V1 : Control annual grass and weeds on the levee slopes and easements.					
Inspector Comment

View of the annual grass along the waterside slope.

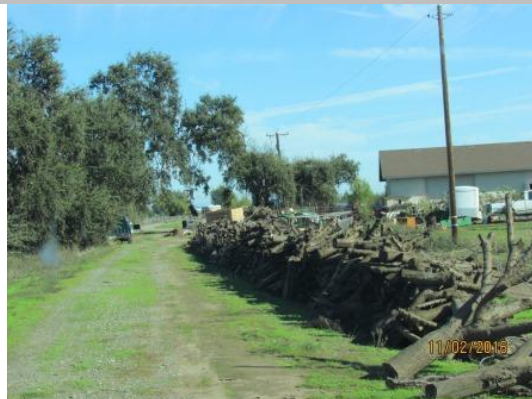
Photo 1 of 1 : FA_2016_ST0020_214_32_20161107_00048.jpg

View of the firewood along the landside toe.

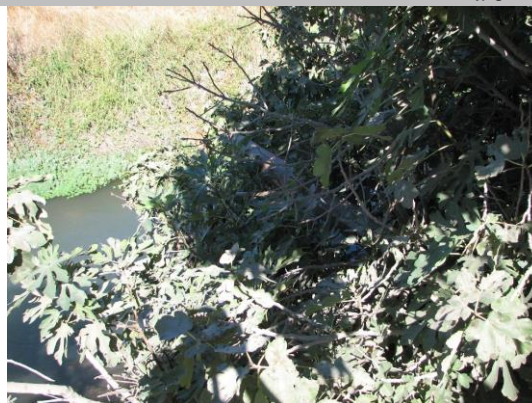
Photo 1 of 2 : UCIP_FA_2016_50335_11363.jpg

Comment Code					
Inspector Comment					
FS_ID:50335 DS_ID:19425 EP_NO: N/A Repair Type: Non-Urgent Crossing Status: Found UCIP Comments: 10/11/2016 Abandoned crossing.(DWR Sutter Yard - afreitag)4/19/2016 Abandoned crossing.5/12/2015 Abandoned crossing.11/17/2014 Same as last inspection.5/12/2014 Same as last inspection.11/4/2013 Same as last inspection.5/15/2013 Same as last inspection.10/16/2012 Pipe and pump abandoned. Pipe should be removed or properly abandoned. FIELD_STRUCT_DESC: 8-inch galvanized iron irrigation pipe through the levee, 2 feet below the crown. 7.5 Horsepower (HP) pump located in canal on the waterside (WS). [Additional Reference(s): DWR Levee Log, Revised 1990. USACE Sacramento O&M Manual 135, revision May 1953, page 11, Location Section 12, As-builts Drawing No. 50-10-2816.] FS Date: 10/12/2016 8:12:30 AM

Pipe on LS slope.

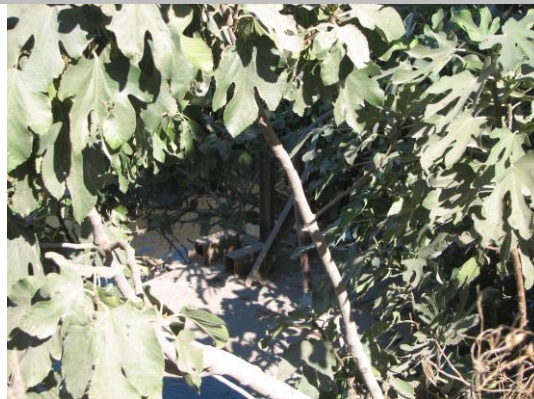
Photo 2 of 2 : UCIP_FA_2016_50335_11362.jpg

Pump platform on LS slope.

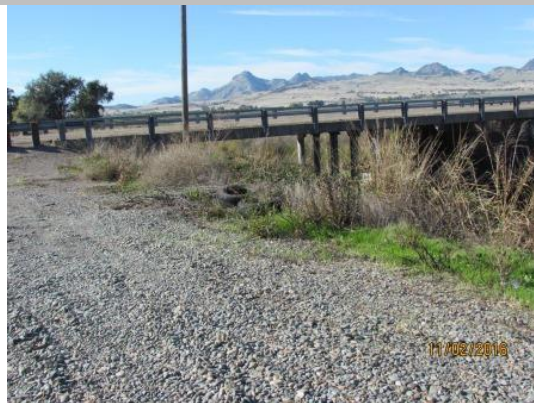
Photo 1 of 1 : FA_2016_ST0020_214_28_20161107_00049.jpg

LM Start	0.53	Rating **	M	Issue No.	28
LM End	0.53	Issue Type +	Ma	Location *	WS
Category	Earthen Levee			GPS Latitude/Longitude	
				Start	End
Item	Encroachments			39.171028 °	39.171028 °
				-121.716475 °	-121.716475 °
DWR ID	DWR_ST0020_02_s_2016_28				
Comment Code					
DE : Debris					
Inspector Comment					
Tires and tree clippings on w/s crown.

View of the tires along the waterside berm.

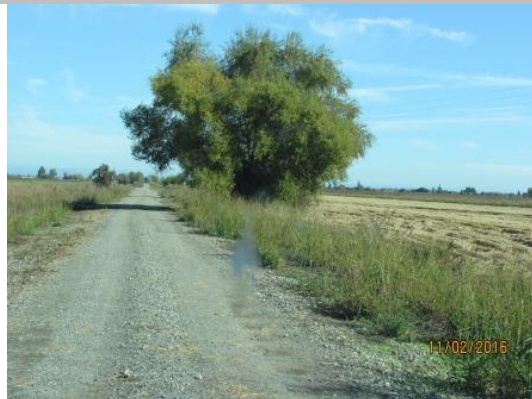
Photo 1 of 1 : FA_2016_ST0020_214_2_20161107_00050.jpg

View of the vegetation on both slopes.

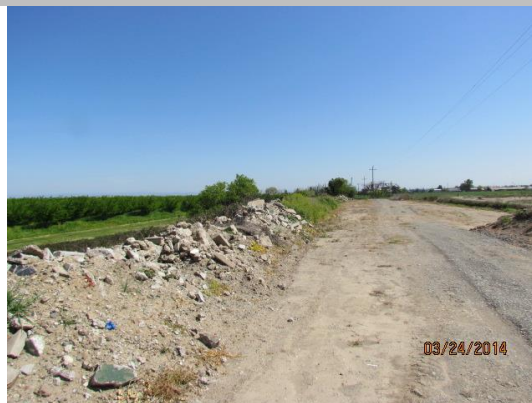
Photo 1 of 2 : FA_2016_ST0020_214_3_20160823_00003.jpg

LM Start	1.43	Rating **	M	Issue No.	3
LM End	1.52	Issue Type +	Ma	Location *	LS
Category	Earthen Levee			GPS Latitude/Longitude	
				Start	End
Item	Encroachments			39.170782 °	39.170865 °
				-121.700167 °	-121.698165 °
DWR ID	DWR_NA0020_02_s_2012_3				
Comment Code					
DE : Debris					
Inspector Comment					
Remove the broken concrete.

View of the piles of broken concrete.

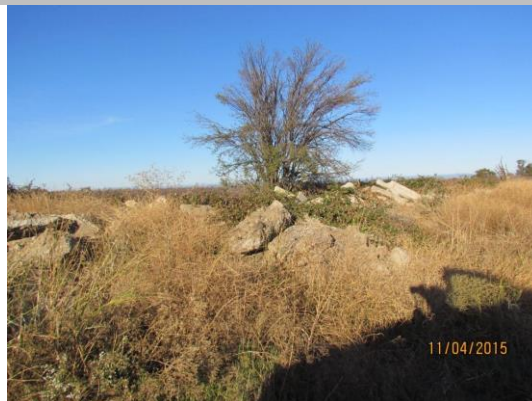
Photo 2 of 2 : FA_2016_ST0020_214_3_20160823_00004.jpg

View of the pile of broken concrete.

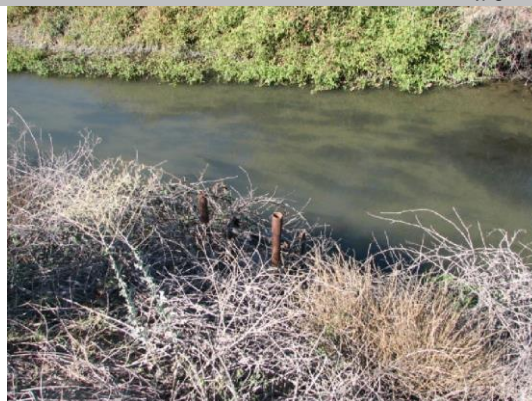
Photo 1 of 2 : UCIP_FA_2016_50341_11406.jpg

FS_ID:50341
DS_ID:19423
EP_NO: N/A
Repair Type: Non-Urgent
Crossing Status: Found
UCIP Comments: 10/11/2016 LS inlet is buried and WS flapgate is overgrown with blackberries.(DWR Sutter Yard - afreitag)4/19/2016 WS flapgate is completely overgrown with blackberries. 5/12/2015 LS inlet still buried with soil and blackberries on WS have blocked the flap gate.LS intake is filled and blocked with soil.11/17/2014 Ws outlet of pipe is overgrown and blocked from opening by blackberries. LS inlet still appears to be buried/blocked by soil.5/12/2014 Same as last inspection.11/4/2013 Same as last inspection.5/15/2013 Same as last inspection.
FIELD_STRUCT_DESC: 16-inch corrugated metal drainage pipe through the levee, 5 feet below the crown. Flap gate located on the waterside (WS) end. Landside (LS) inlet filled and blocked with soil 2012. [Additional Reference(s): DWR Levee Log, Revised 1990]
FS Date: 10/12/2016 8:32:49 AM

Pipe with flapgate at outlet on WS slope.

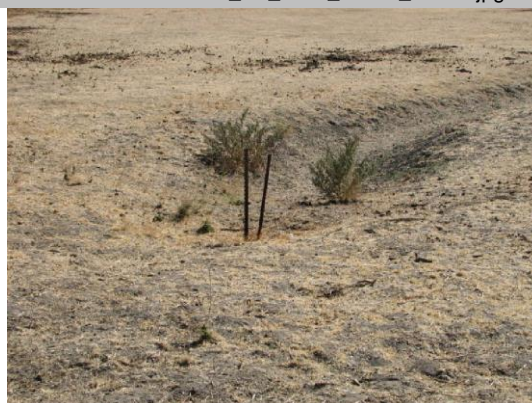
Photo 2 of 2 : UCIP_FA_2016_50341_11405.jpg

Buried inlet 30 feet from LS shoulder.

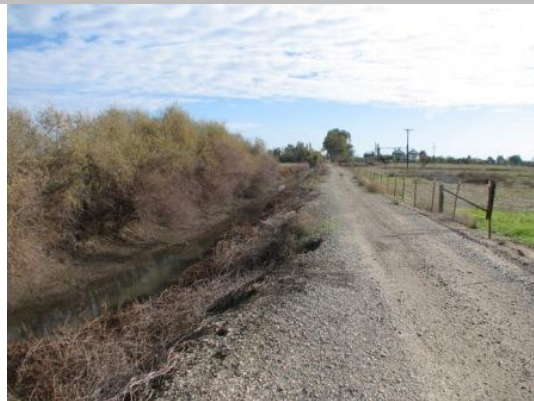
Photo 1 of 2 : FA_2016_ST0020_214_4_20160823_00005.jpg

View of the erosion along the waterside slope.

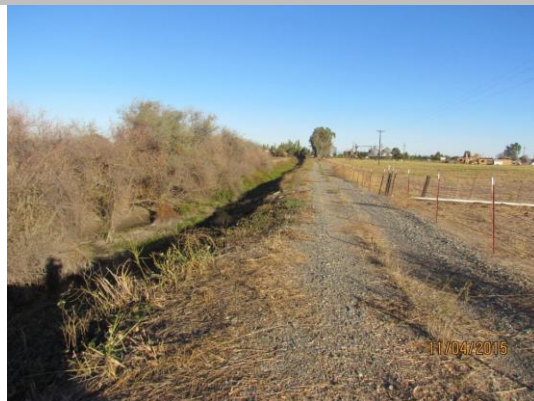
Photo 2 of 2 : FA_2016_ST0020_214_4_20160823_00006.jpg

View of the erosion along the waterside slope.

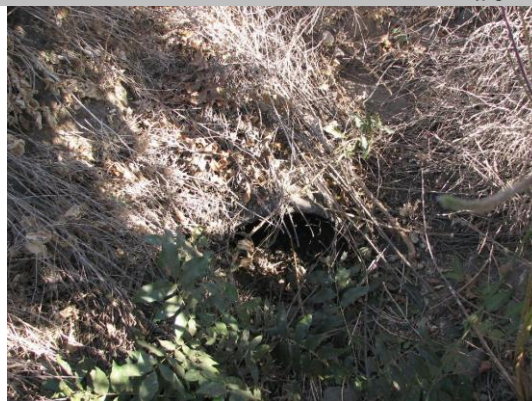
Photo 1 of 2 : UCIP_FA_2016_50353_14374.jpg

FS_ID:50353
DS_ID:20127
EP_NO: N/A
Repair Type: Non-Urgent
Crossing Status: Found
UCIP Comments: 10/11/2016 WS flap gate is being overgrown by blackberries that could possibly hinder its operation. They should be sprayed and cleared back.(DWR Sutter Yard - afreitag)4/19/2016 Crossing appears to be in good condition.5/12/2015 Crossing appears in good condition. No noticeable issues to report.11/17/2014 Same as last inspection.5/12/2014 Same as last inspection.5/15/2013 Same as last inspection.11/4/2013 Same as last inspection.10/16/2012 No permit identified for this crossing.
FIELD_STRUCT_DESC: 18-inch asphalt coated corrugated metal drainage pipe through the levee, 6 feet below the crown. Flap gate is located on the waterside (WS). Pipe is visible on the landside (LS) toe. No permit has been identified since crossing was field discovered in 2012.
FS Date: 10/12/2016 9:27:19 AM

Pipe on LS toe.

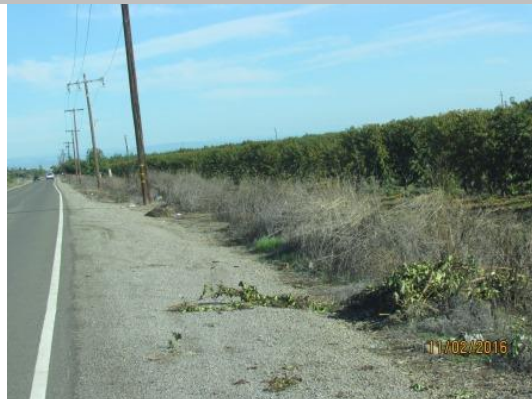
Photo 1 of 1 : FA_2016_ST0020_214_6_20161107_00051.jpg

View of the annual grass along the landside slope blocking visibility.

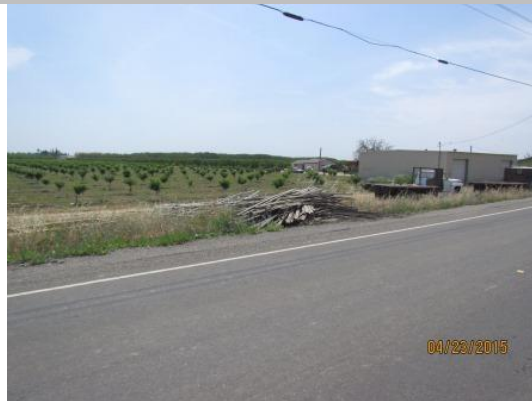
Photo 1 of 1 : FA_2016_ST0020_214_10_20160823_00010.jpg

LM Start	2.71	Rating **	M	Issue No.	10
LM End	2.71	Issue Type +	Ma	Location *	LS
Category	Earthen Levee			GPS Latitude/Longitude	
				Start	End
Item	Encroachments			39.170548 °	39.170548 °
				-121.675970 °	-121.675970 °
DWR ID	DWR_NA0020_02_s_2012_10				
Comment Code					
MA : Material					
Inspector Comment					
Remove the lumber, garbage and equipment from the landside toe.

View of the material, garbage, and equipment along the landside toe
